Subject: Condition Review of Remaining Exterior Walls of  
Bisbee City Hall after Fire-Damage  
Owner: City of Bisbee  
SCI Project Number: 18-127

Bisbee City Hall  
Prior to Fire

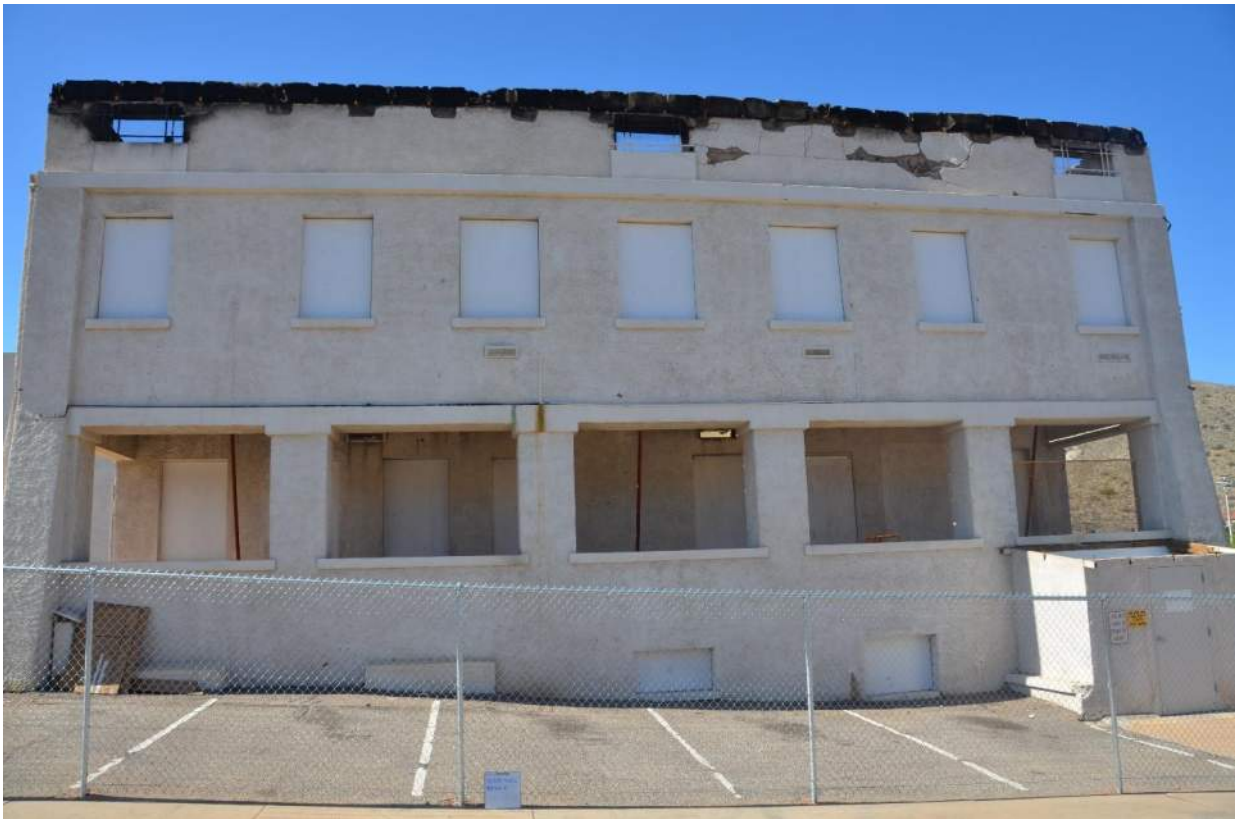
3 – North Side

Substantial cracking and fire damage was observed at the top portion of the northern wall. Reference Photos 3-5 and 12-14.

1. The portions of the northern wall observed to be substantially cracked and damaged by the fire are not adequate for use.
2. The amount of steel reinforcement detected in the existing original walls, where present, is substantially less than minimum reinforcement requirements specified by current building code.
3. Results of compression tests of core samples taken from the building are widely ranging and are typically very low. This indicates concrete of nonuniform quality and generally poor strength.

Based on these conditions, use of the existing original walls for structural purposes in rebuilding will be difficult and require substantial reinforcement by other, new structural means.

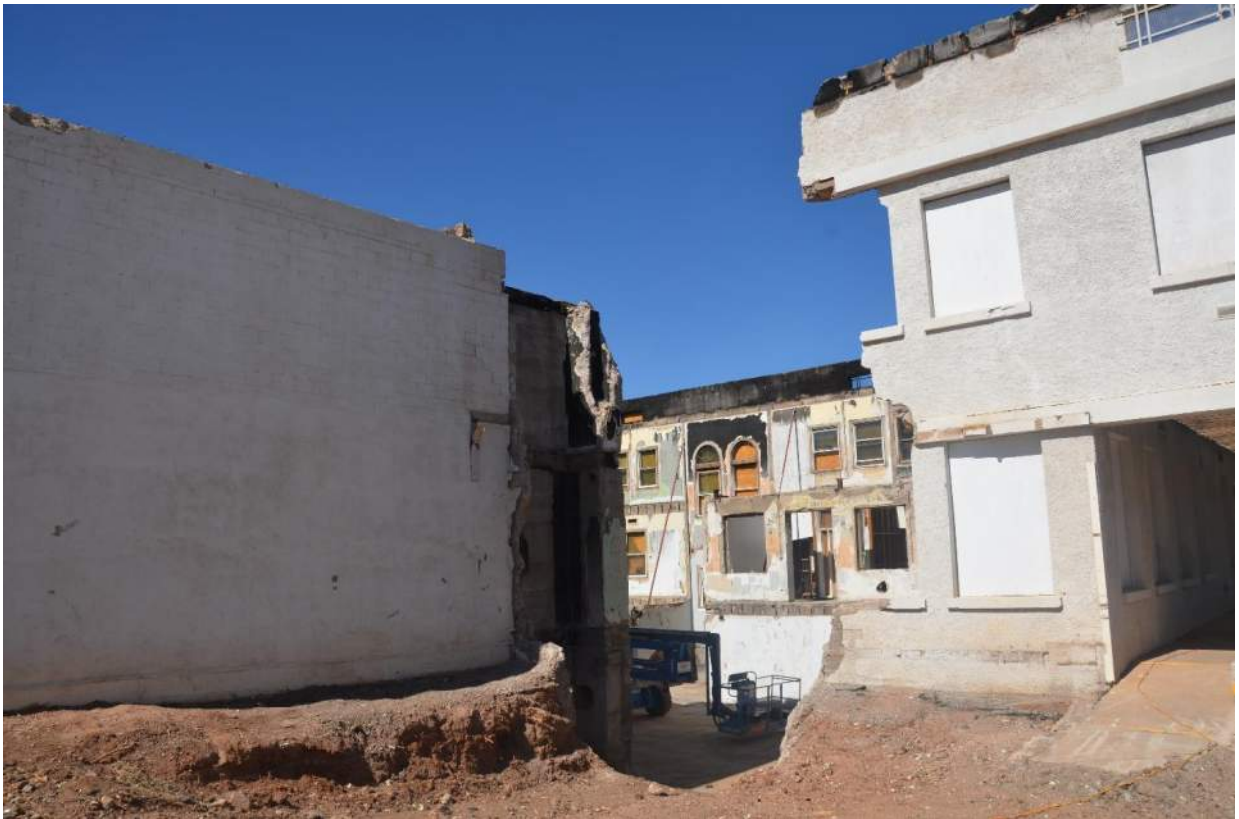
7 – Demolished Wall Opening

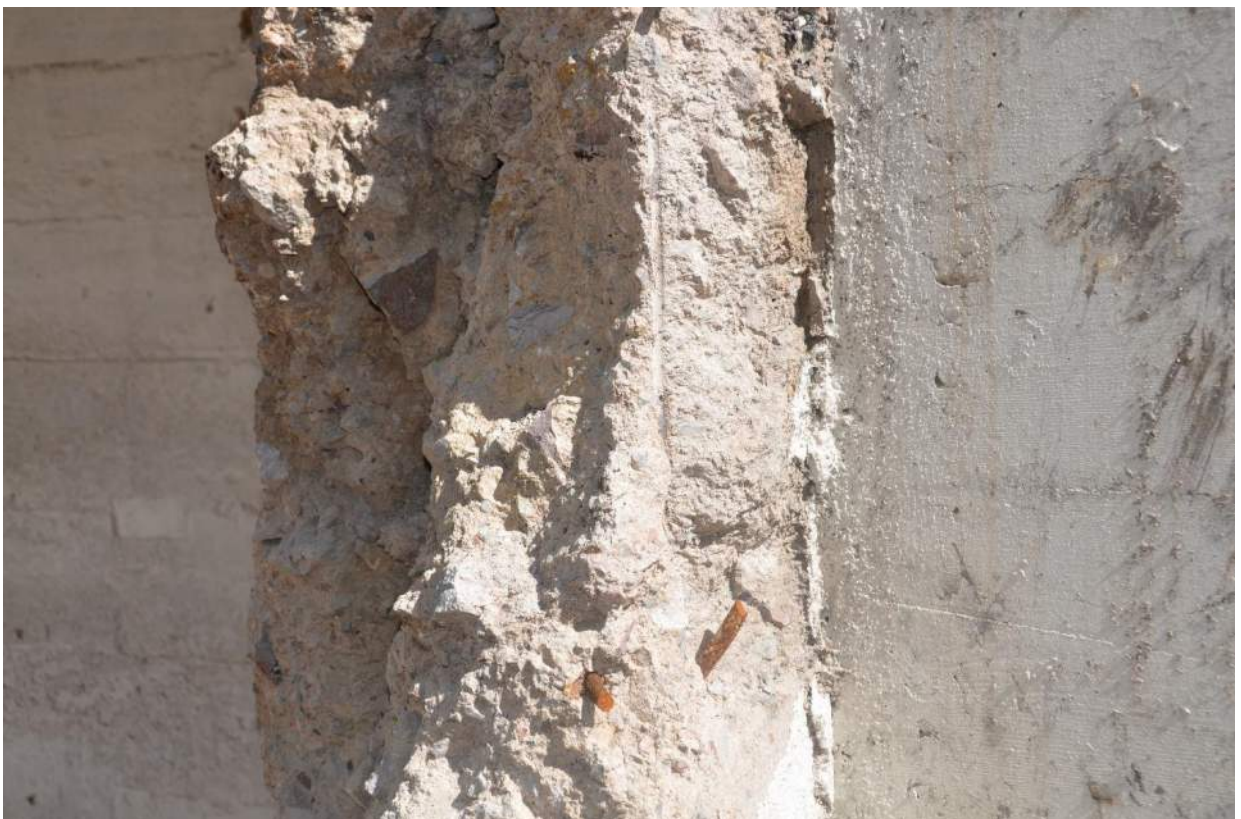
3. Interior basement walls measured to be 12" thick and have no reinforcement.
4. Exterior walls above grade are 12" thick with 3/8"-diameter smooth bars spaced at 16" horizontally and 12" vertically. Bars appear to be off center, located approximately three inches from the exterior face of the walls. One bar detected vertically on both sides of door opening and horizontally above door opening.

26– Close-up of Rebar at Wall Opening
